<i>Seabed Sampling and Baited Camera Operations</i>	
Vessel	R/V Ocean Veritas
Summary Report Number	04
Operating equipment	MAXI Corer (8 core unit)
Date	28 September 2010
Completed casts (12 hr)	5
Report compiled by	Brian Critchley/Emily Gould

### Seabed Sampling Locations

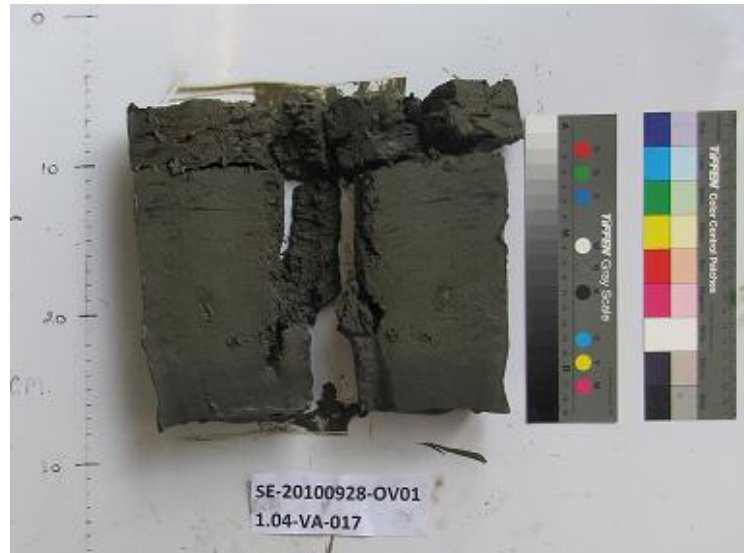
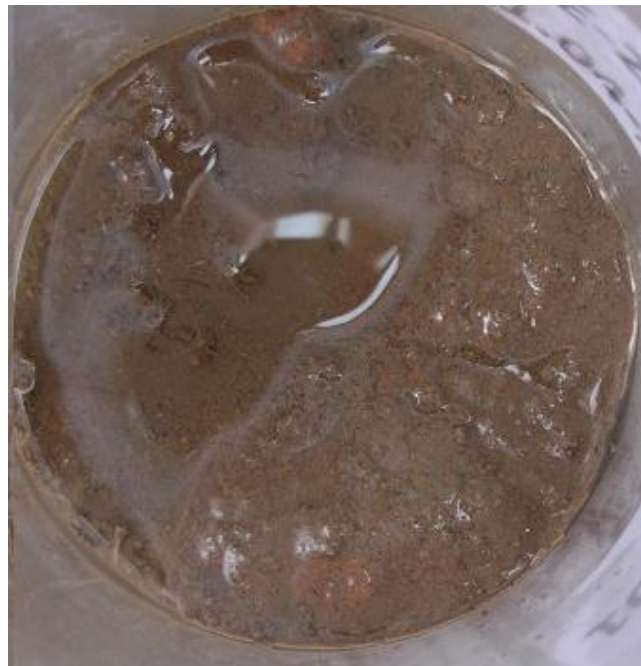
## Station 1-04

Recovery: 33 cm

Recovery: 27 cm

Visible contamination: None

Olfactible contamination: None

*Description* Dark olive brown fluidized sediment to approximately 1 cm depth. Olive grey, very soft, homogenous silty clay, becoming soft to firm.

Biota: Worms.

Top 3 cm removed for GC/MS analysis prior to core extrusion.

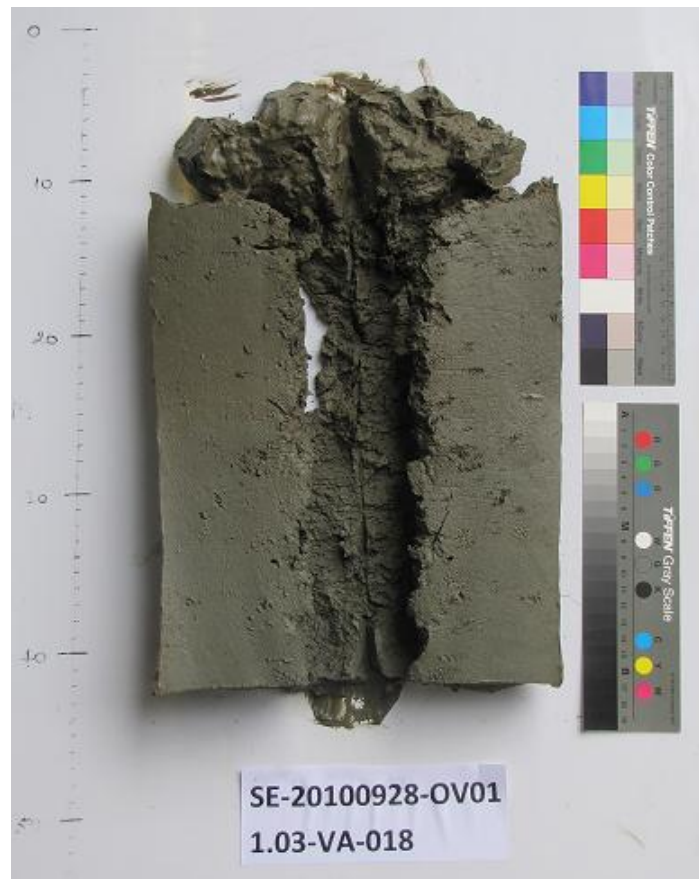
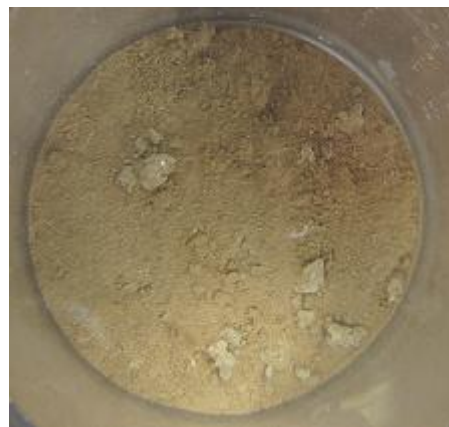
### Station 1-03

Recovery: 19 cm

Recovery: 41 cm

Visible contamination: None

Olfactible contamination: None

Description: Dark olive brown fluidized sediment to approximately 1 cm depth. Olive grey, soft to firm, homogenous silty clay.

Biota: Worms.

Top 3 cm removed for GC/MS analysis prior to core extrusion.

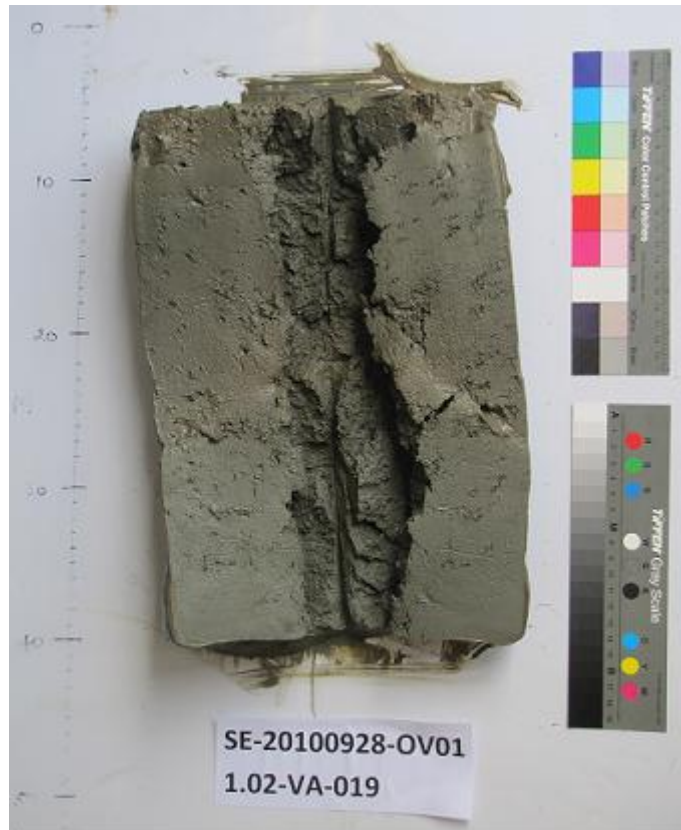
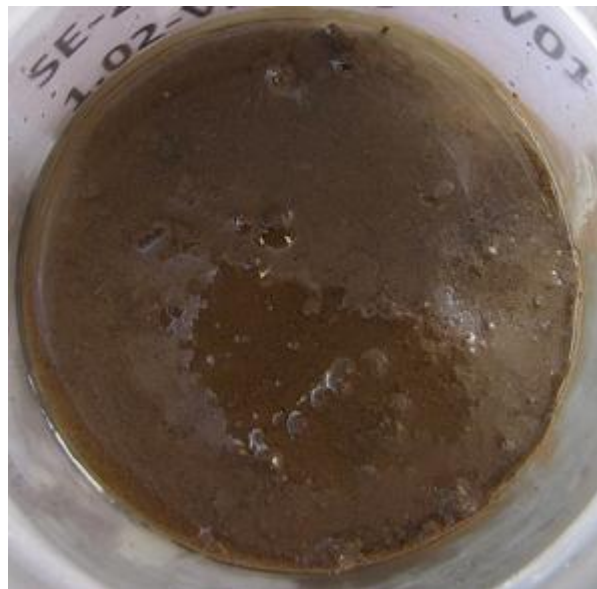
## Station 1-02

Recovery: 20 cm

Recovery: 40 cm

Visible contamination: None

Olfactible contamination: None

Description: Dark olive brown fluidized sediment to approximately 1 cm depth. Olive grey, soft to firm, homogenous silty clay.

Biota: Worms.

Top 3 cm removed for GC/MS analysis prior to core extrusion.

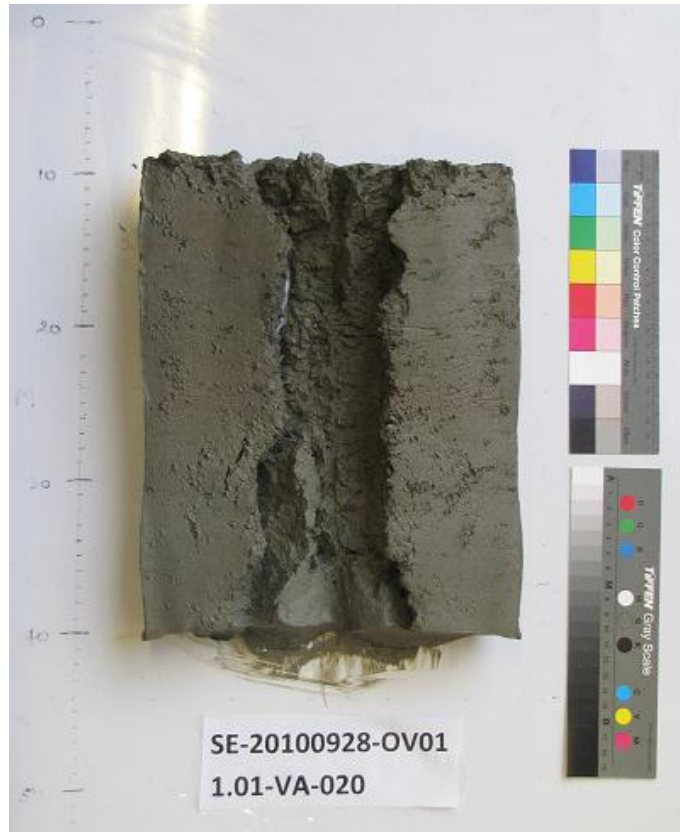
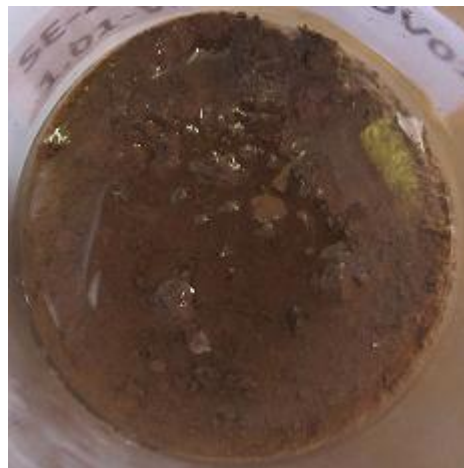
## Station 1-01

Recovery: 25 cm

Recovery: 35 cm

Visible contamination: None

Olfactible contamination: None

Description: Dark olive brown fluidized sediment to approximately 2 cm depth. Olive grey, very soft, homogenous silty clay, becoming soft to firm.

Biota: Shark scoot.

Top 3 cm removed for GC/MS analysis prior to core extrusion.

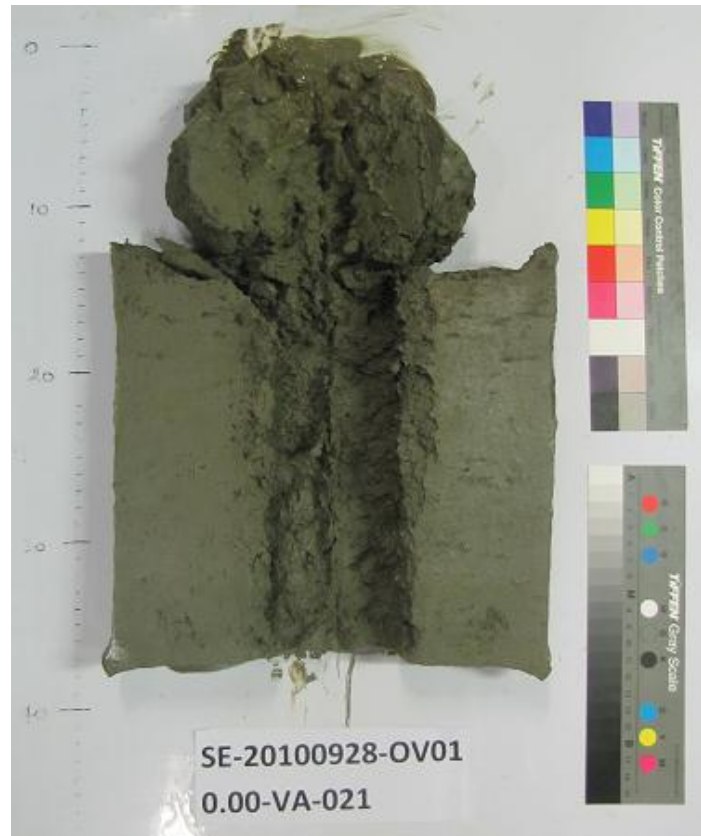
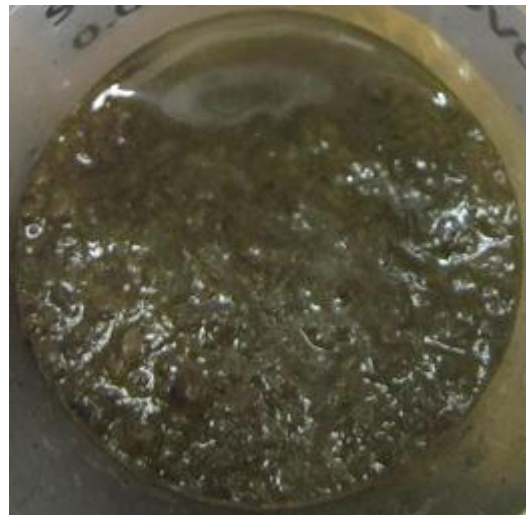
## Station 0-00

Recovery: 21 cm

Recovery: 39 cm

Visible contamination: None

Olfactible contamination: None

Description: Dark olive brown fluidized sediment to approximately 3 cm depth. Olive, very soft, homogenous silty clay, becoming soft.

Biota: Worm tubes visible.

Top 3 cm removed for GC/MS analysis prior to core extrusion.
